THE ROAD TO CIRCULARITY: A FRAMEWORK FOR AND EXPERIENCES IN COLLECTING ROAD DATA IN A CIRCULAR RENOVATION PROCESS

BRAM ENTROP

Saxion University of Applied Sciences, School of Business, Building & Technology, Research Group Sustainable Environment, M.H. Tromplaan 28, 7513 AB, Enschede, The Netherlands

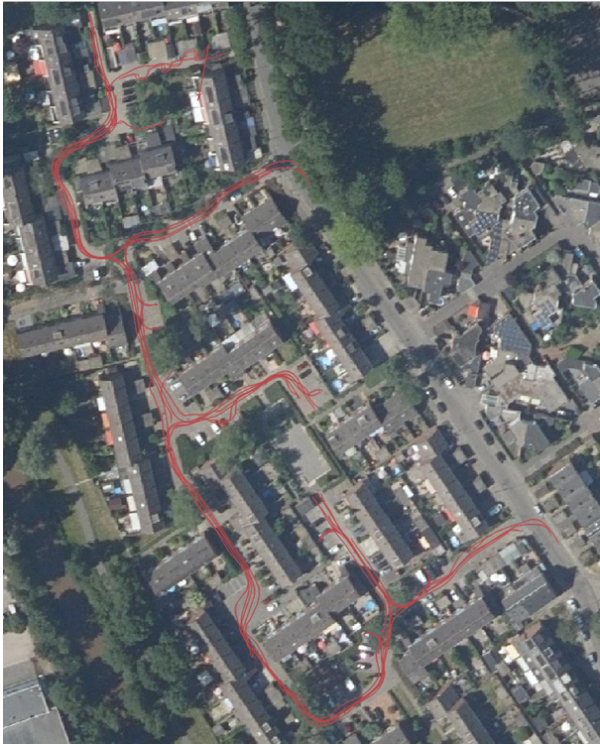
FIGURE 2. Lines of measurement in Griffiersveld.

In order to test if we can easily complete the data automatically, an initial scan of Griffiersveld was made on the 7th of April 2020. An IDS RIS Hi-Pave ground penetrating radar system at the back and a gamma spectrometer at the front of a van were used. The van drove approximately five times through Griffiersveld resulting in a dataset, that seems to consist of lines, but are in fact measuring points in close proximity (see Figures 2 and 3). The data collected by the gamma spectrometer offered insights into radioactivity levels (in Bq/kg) of pavements. The ground penetrating radar made it possible to assess the type of pavement and its thickness, namely around 5 cm thick concrete paving slabs and 8 cm thick concrete pavers. Furthermore, it was possible to get insights into the thickness of the sand package under the pavement, that seems to vary from 1.4 to 22.0 cm.

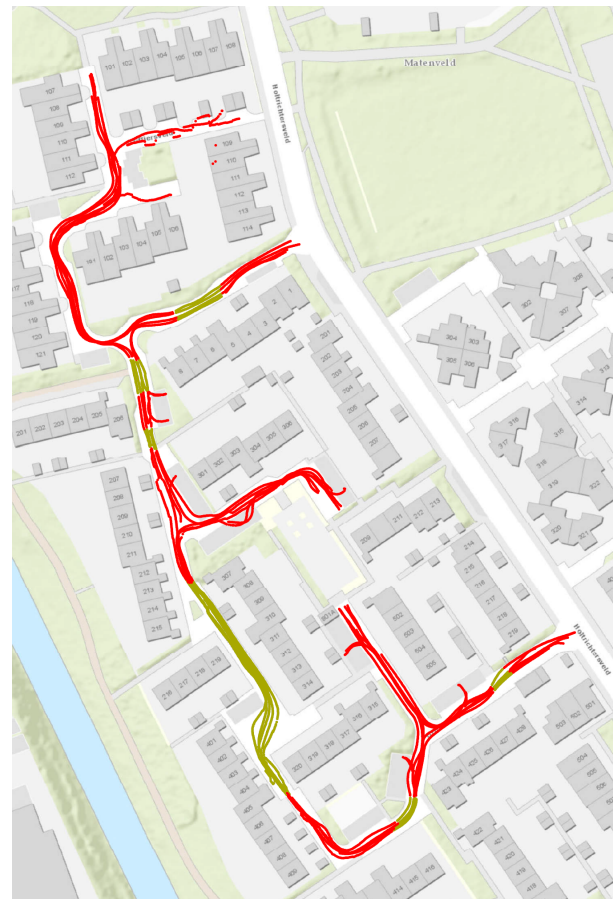
FIGURE 3. Applied pavement materials (red = concrete pavers, green = concrete paving slabs).

Due to the data collection method during the first scan process, material differences remained unnoticed by the sensors around two speed bumps consisting of pavers instead of slabs. Also multiple footpaths were outside the scope of the data collection. However, in particular places sensors did notice that the thickness of the upper layer of the road changed, while this was not properly recorded in GBI. The asset management system mentioned the presence of concrete paving slabs here, but in fact concrete pavers are in place. These were probably put there after repairs had been made.
